Haystack Dam & Equalizing Reservoir

Construction Period: 1956-1957

Location: Offstream about 10 miles south of Madras, OR

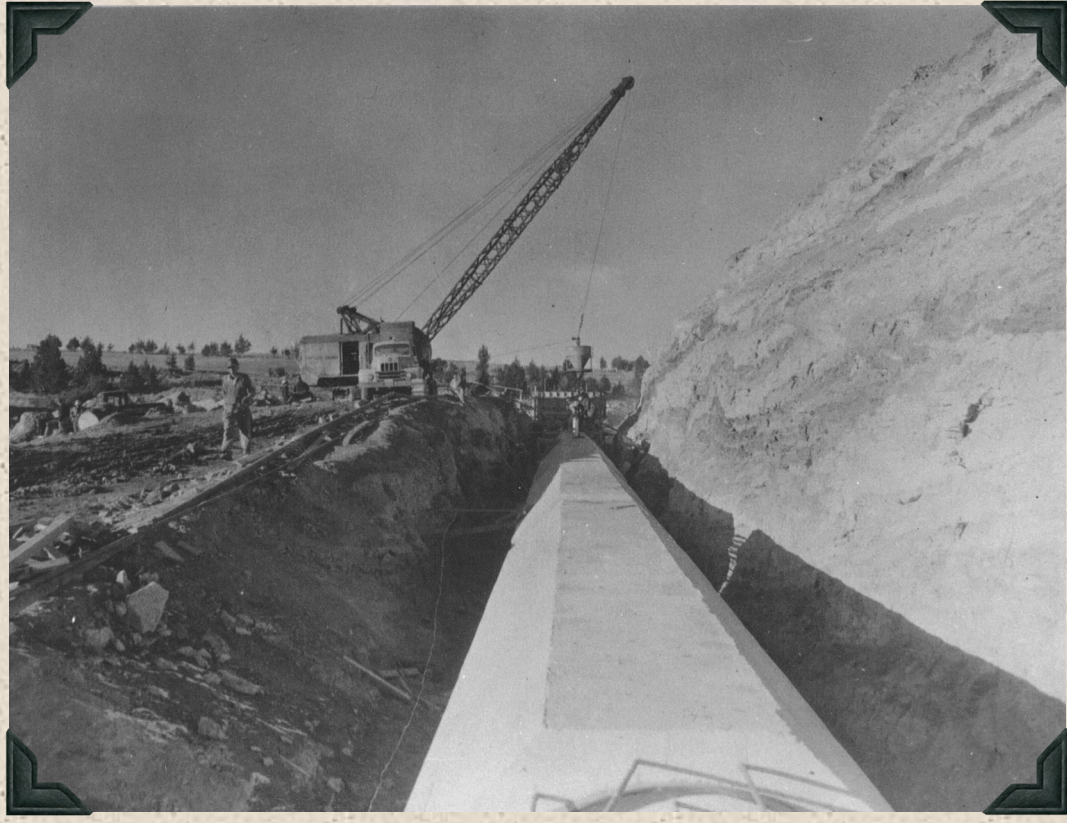
1956 - Outlet-works upstream conduit concrete in place prior to placing cut-off collars.

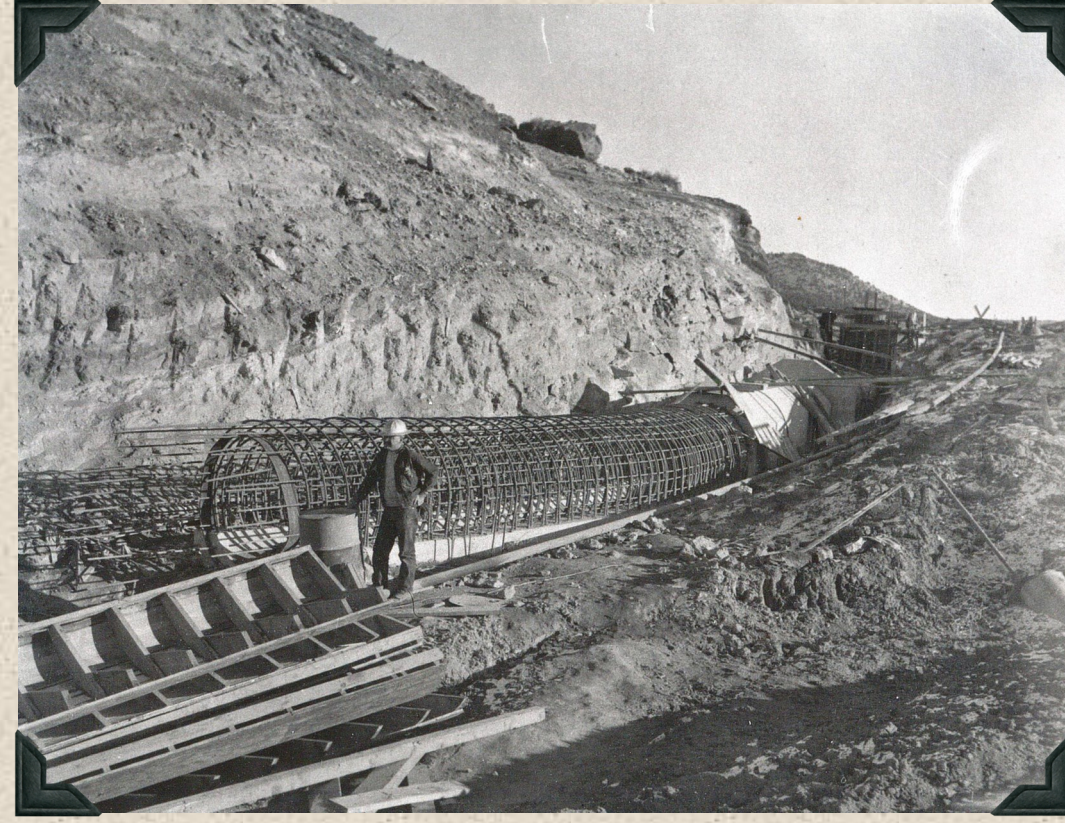
1956 - Reinforcement steel in upstream section of outlet-works conduit.

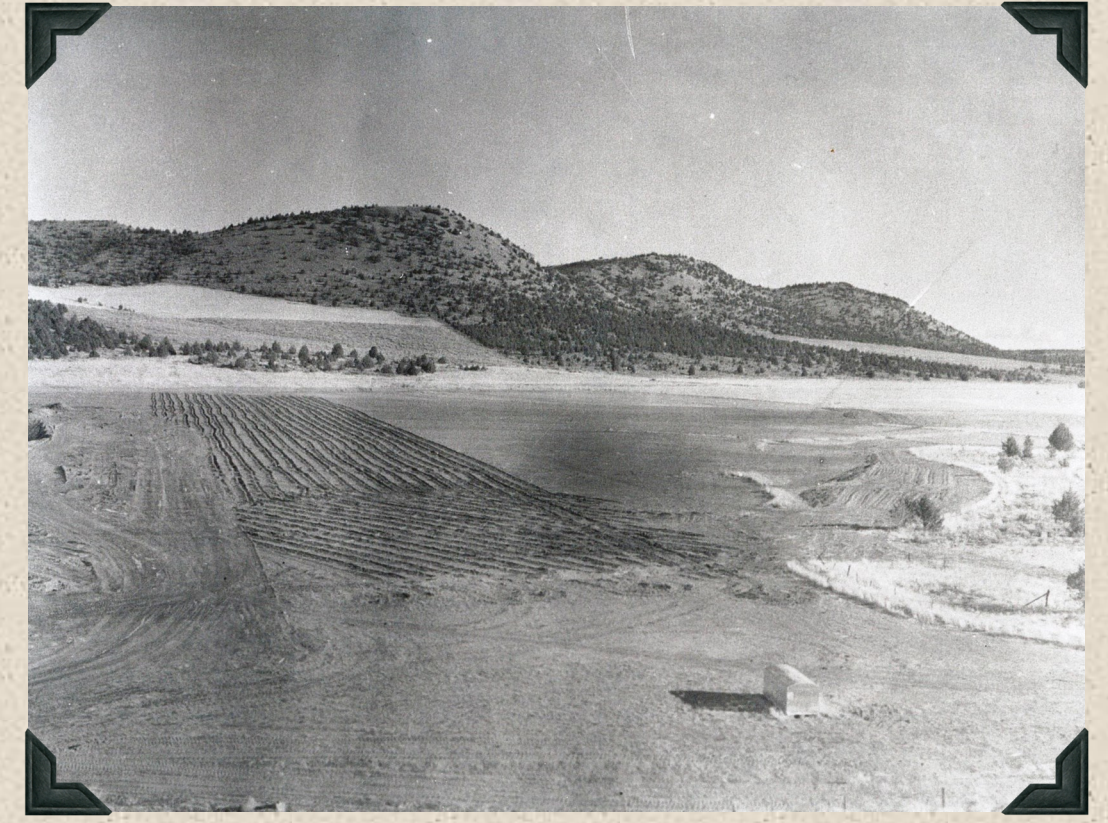
1956 - Borrow area #1 in Haystack Reservoir site.

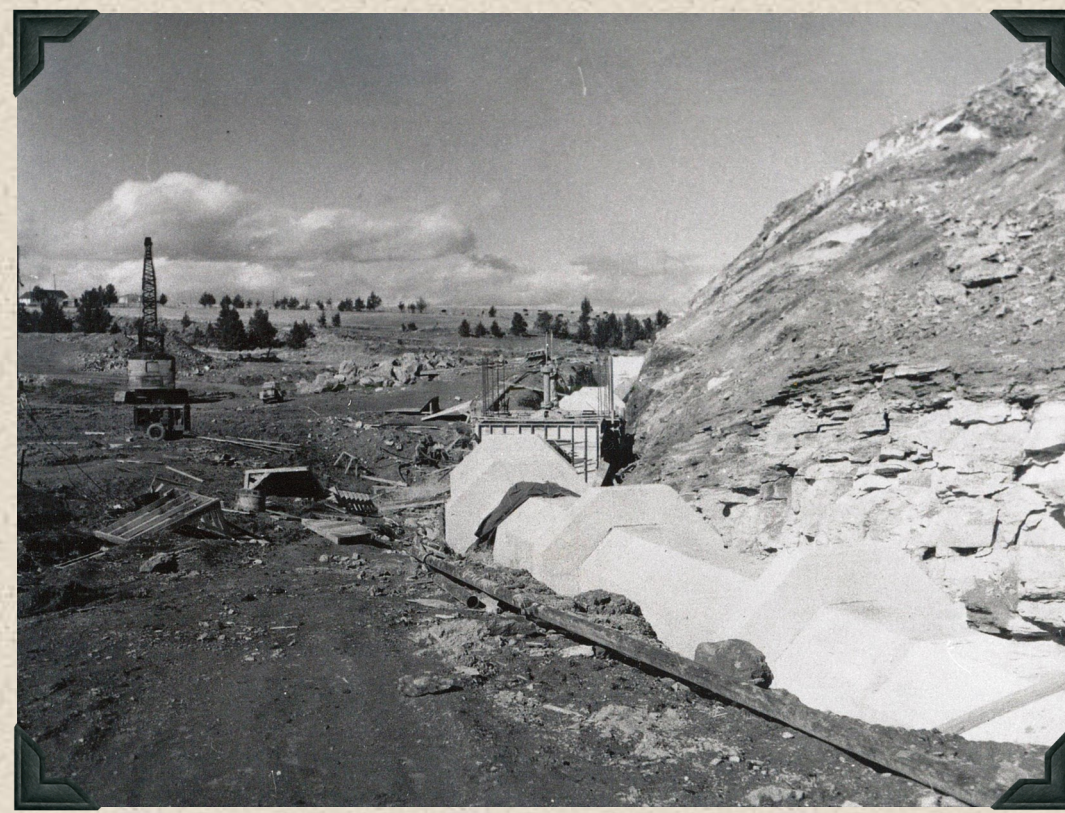
1957 - Completed upstream section of concrete outlet-works conduit and cut-off collars.

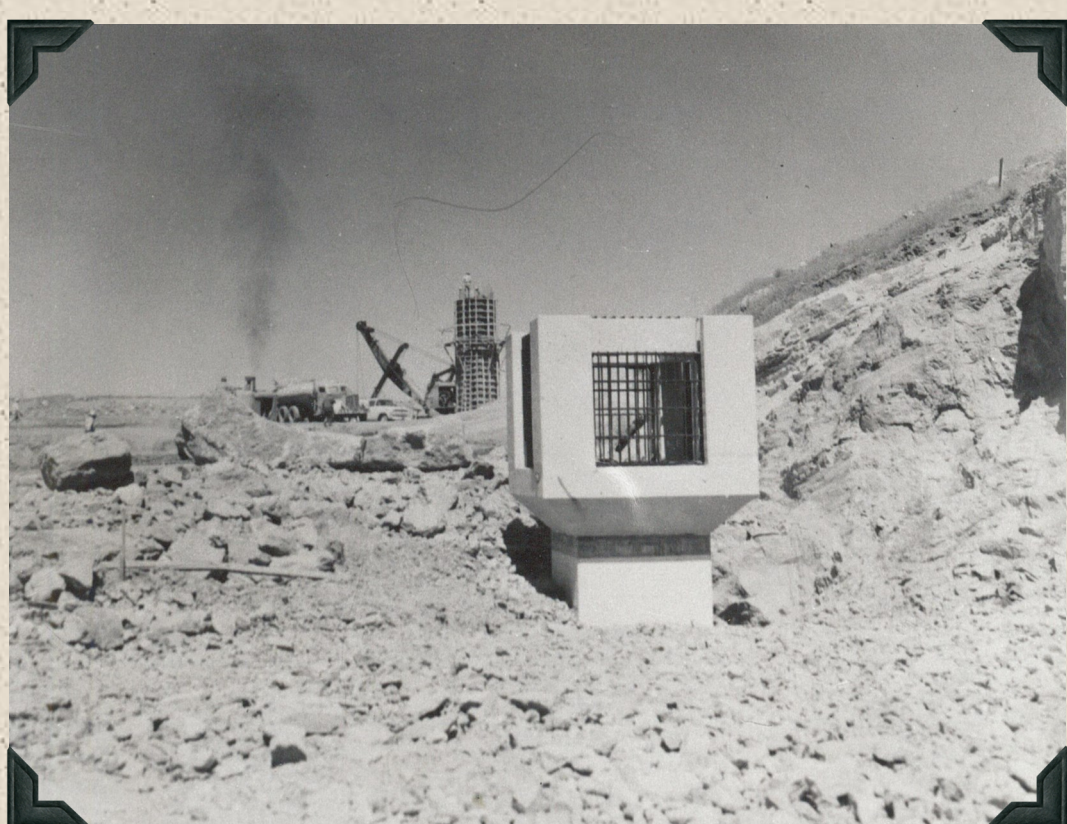
1956 - Intake structure of outlet works.

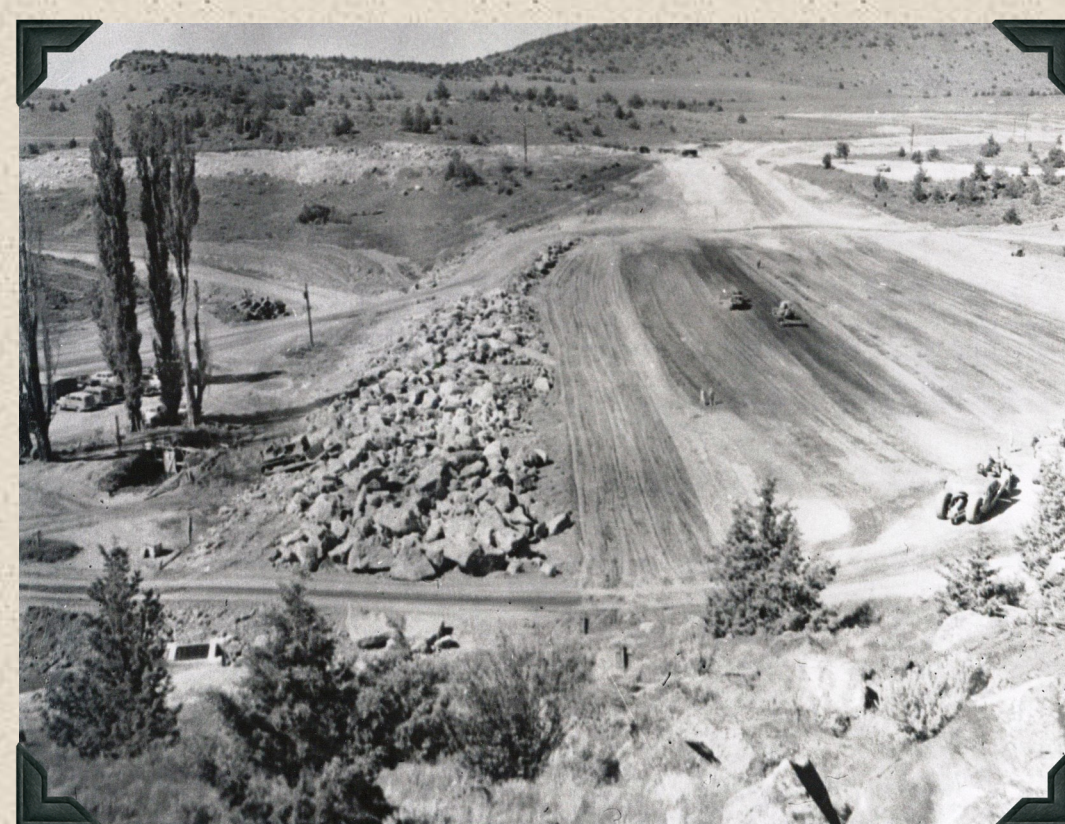
1957 - Placing earth and rockfill in dam embankment in zones 1, 2 and 4.

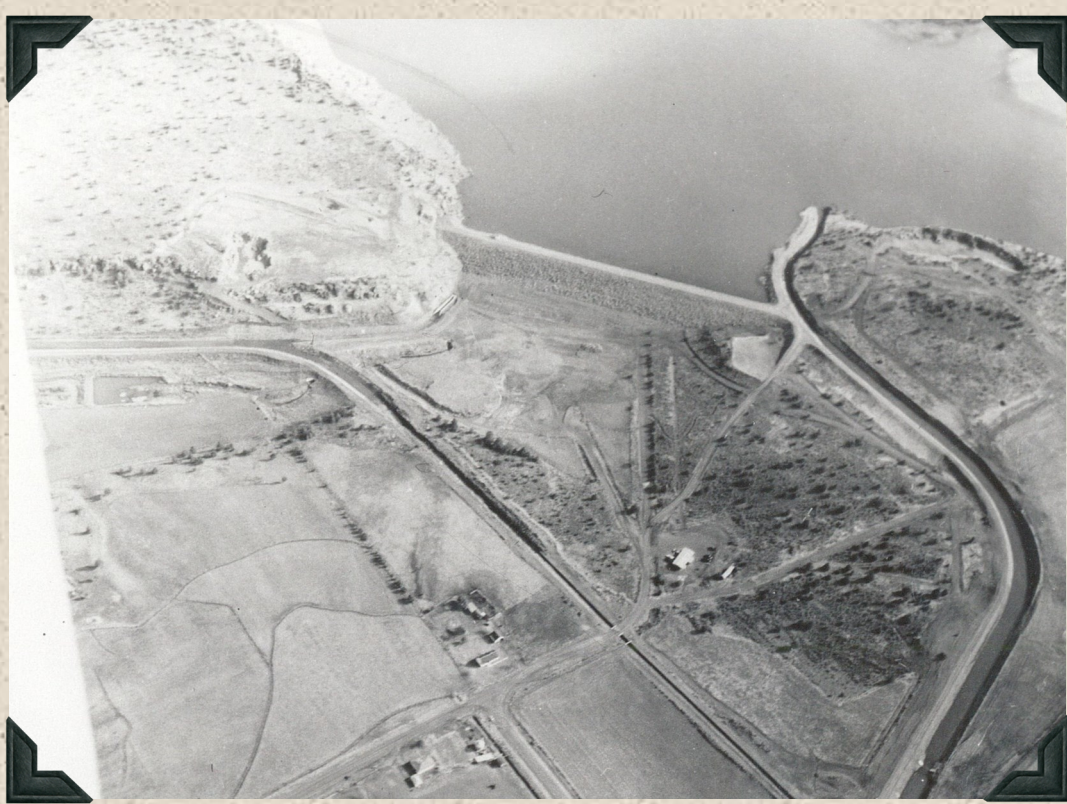
1958 - Aerial view of Haystack Dam. Feeder canal on the right and North Unit Main Canal in the center and to the left along the base of the right abutment.
