Canals, Laterals & Structures

Construction Period: 1938 - 1948

65 Miles of Main Canal

235 Miles of Laterals

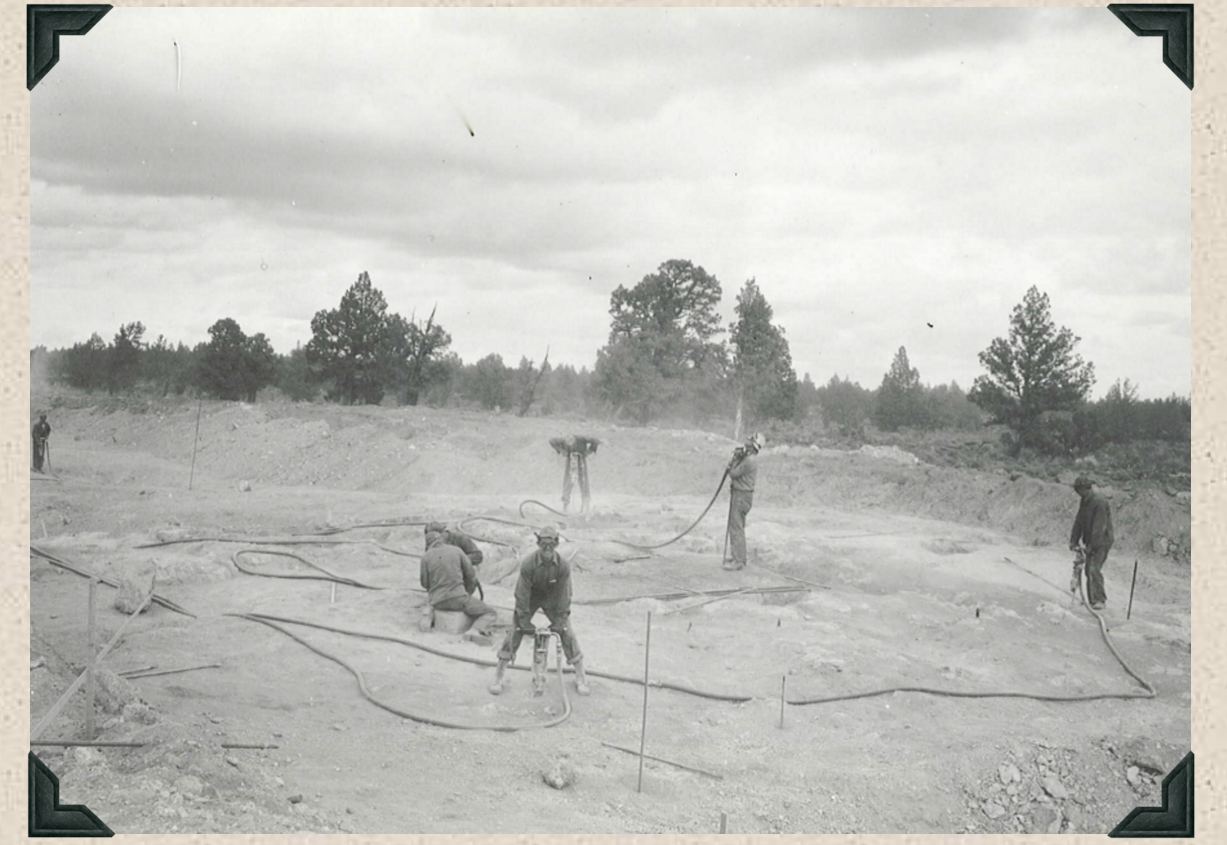
1940 - North Unit Main Canal. Enrollees drilling rock.

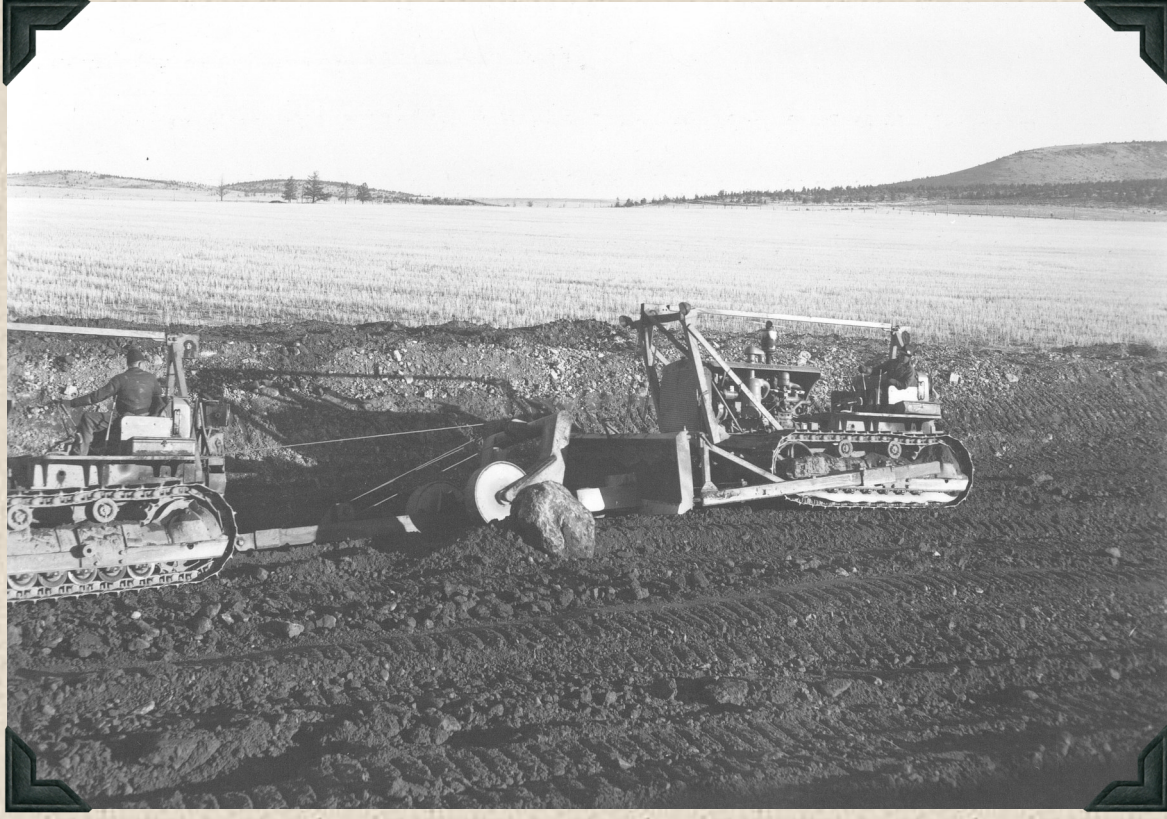
1942 - North Unit Main Canal. Side view of D-8 tractors pulling and pushing a single tooth ripper through hardpan material.

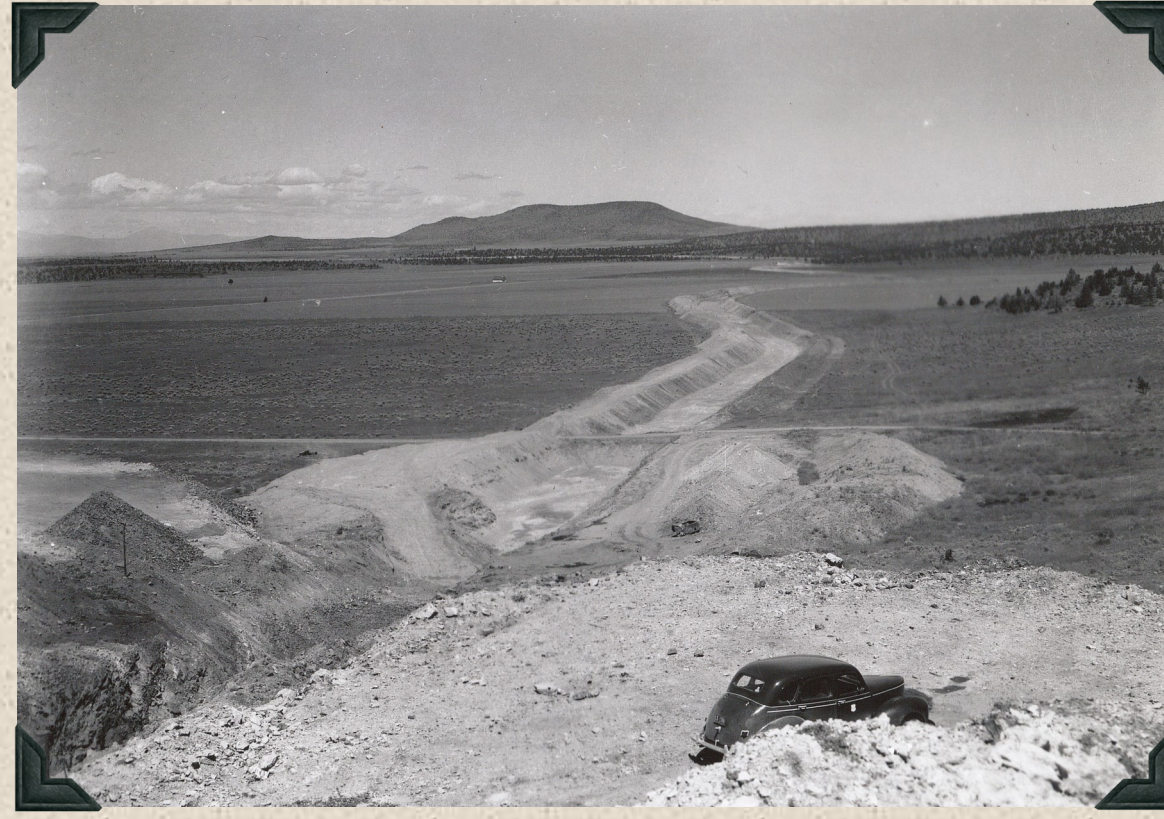
1942 - North Unit Main Canal. Looking downstream from the "Big Cut" towards Trail Crossing area.

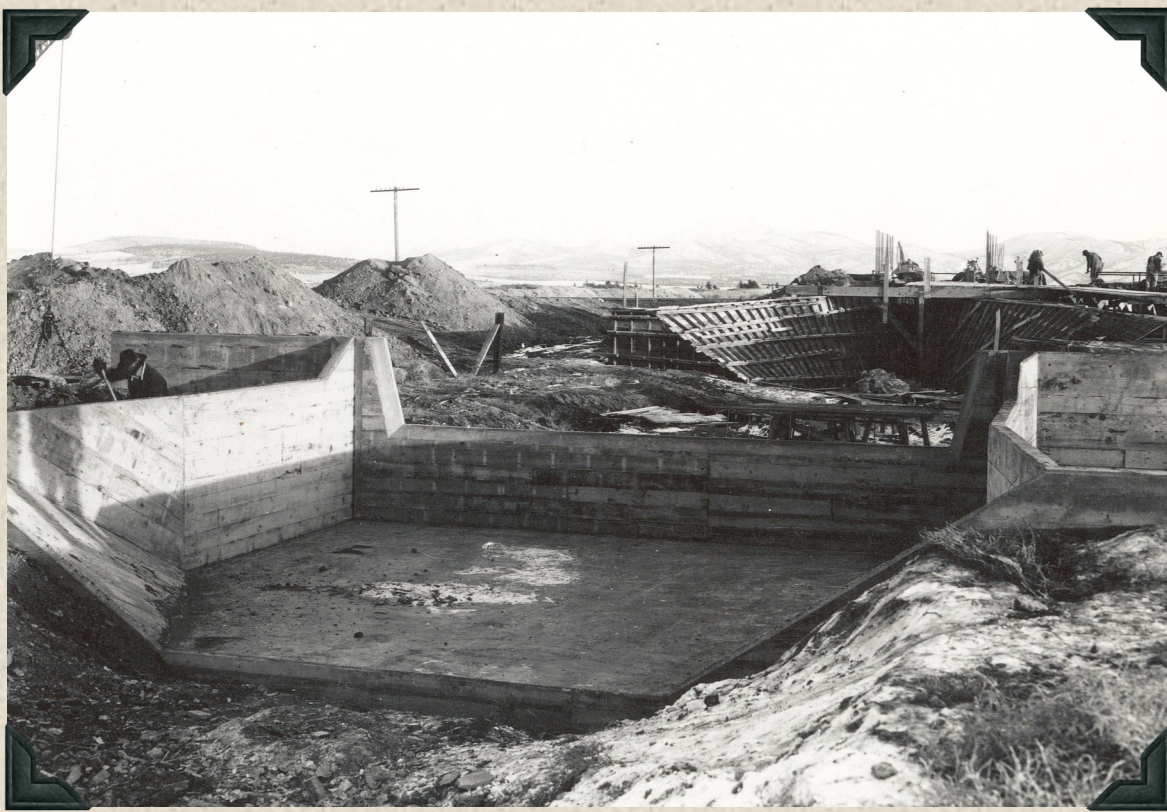
1945 - Lateral M-37 concrete structures. The "M" in M-37 represents mile. In this case the M-37 location is 37 miles downstream from the diversion in Bend.

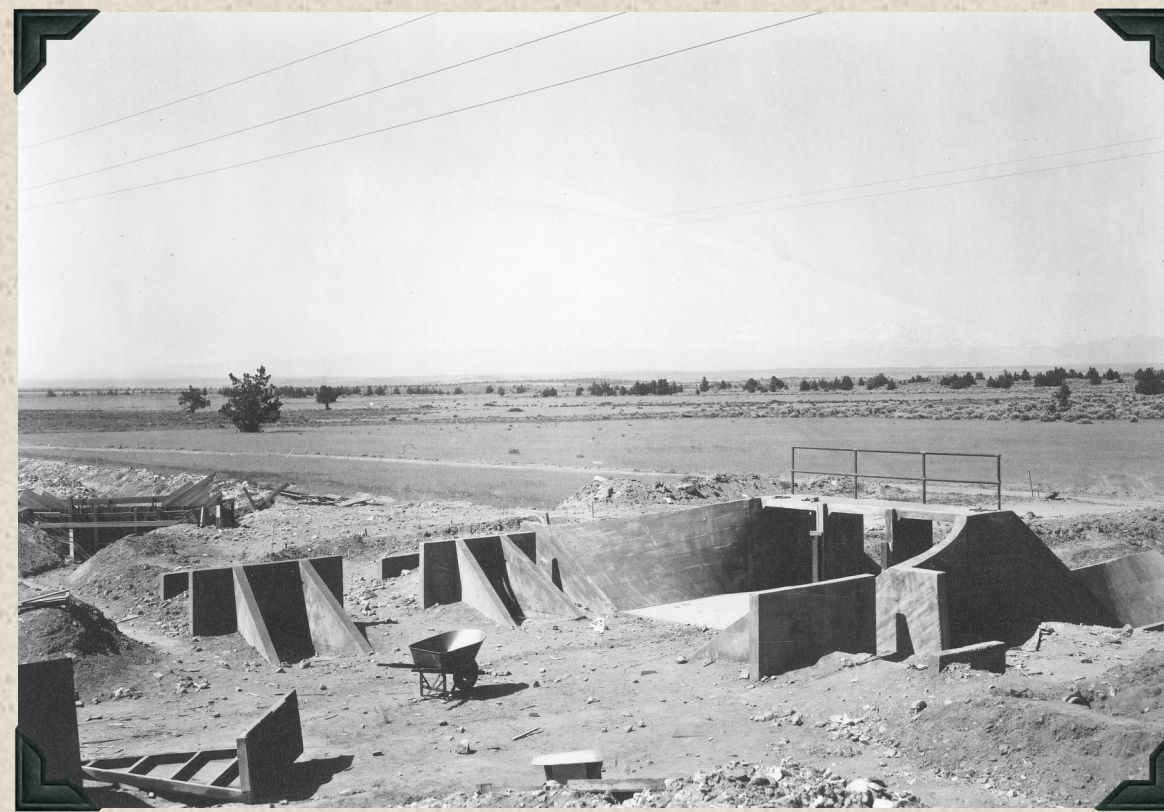
1945 - Lateral M-37 structures. From left to right, forms in place for weir drop on Lateral M-37-1, 24" turnout for Lateral M-37-1, 18" farm turnout to the left and weir visible just over transition wall, 18" farm turnout to the right, and check drop for Lateral M-37.

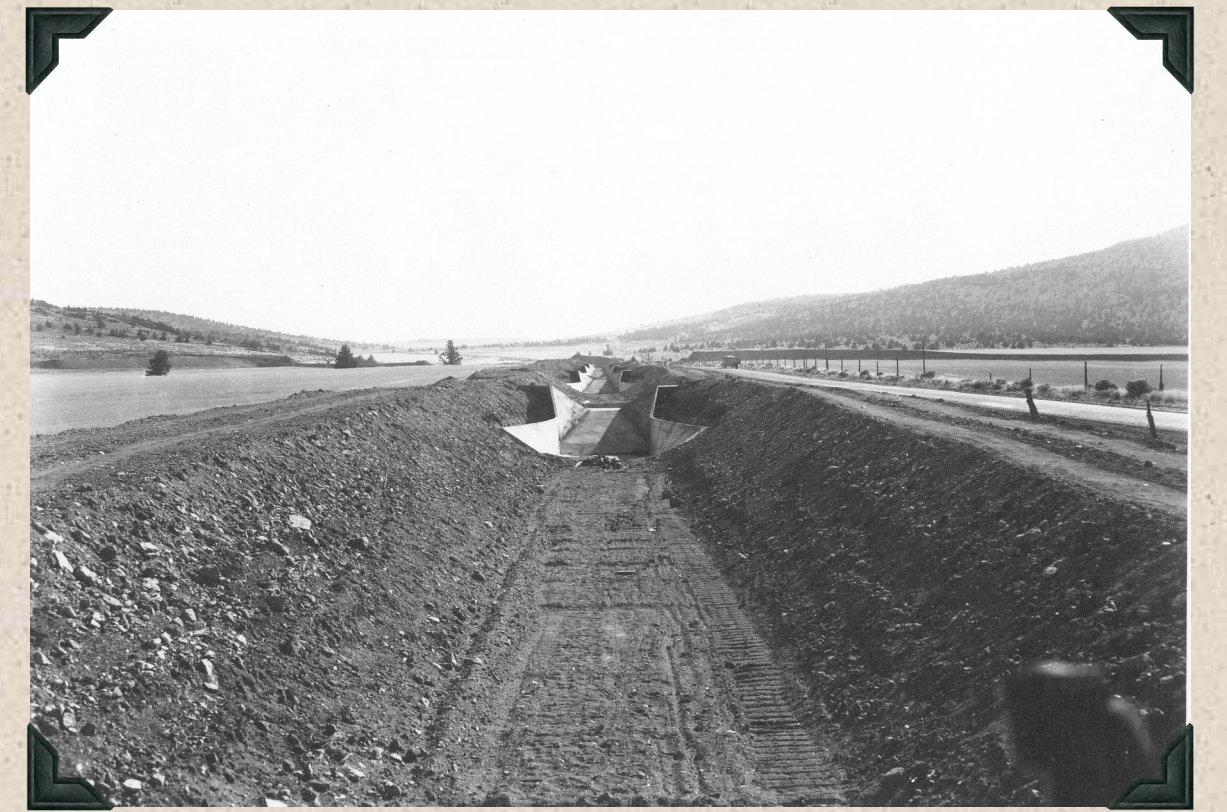
1945 - Lateral M-41, looking upstream from a bridge near Culver, OR. Six concrete drops, immediately after removing forms. North Unit Main Canal is visible at base of timbered slope on right and left. (Blickle & Cater, Contractor)

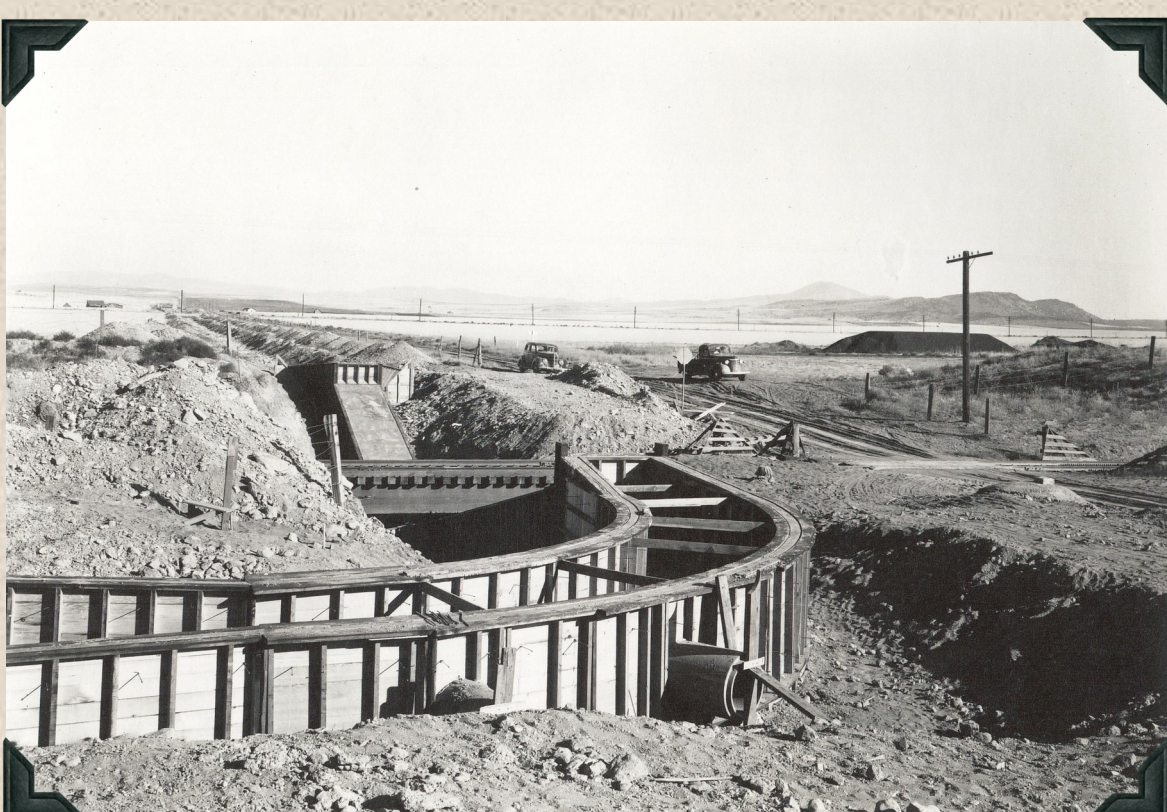
1945 - Lateral M-41, looking upstream at Oregon Trunk Railway crossing, half mile north of Culver, OR. (Blickle & Cater, Contractor)

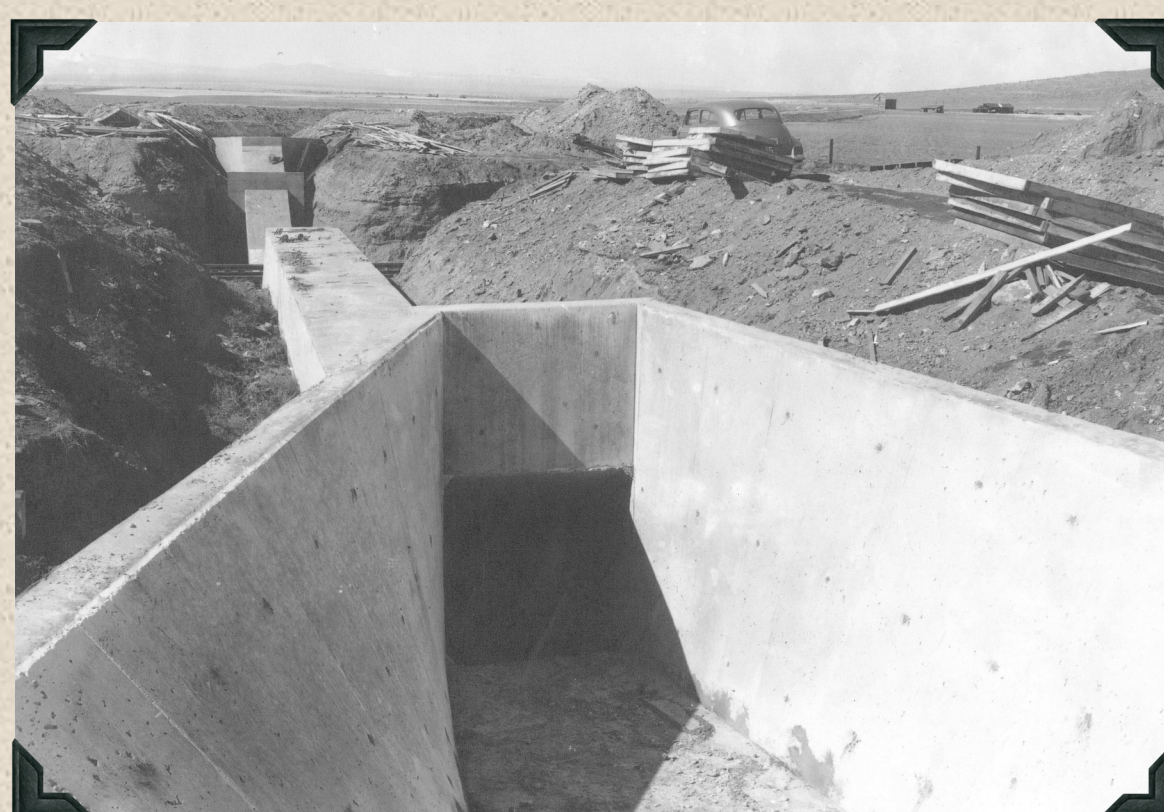
1946 - Highway and railroad crossing on Lateral M-43. Looking downstream.

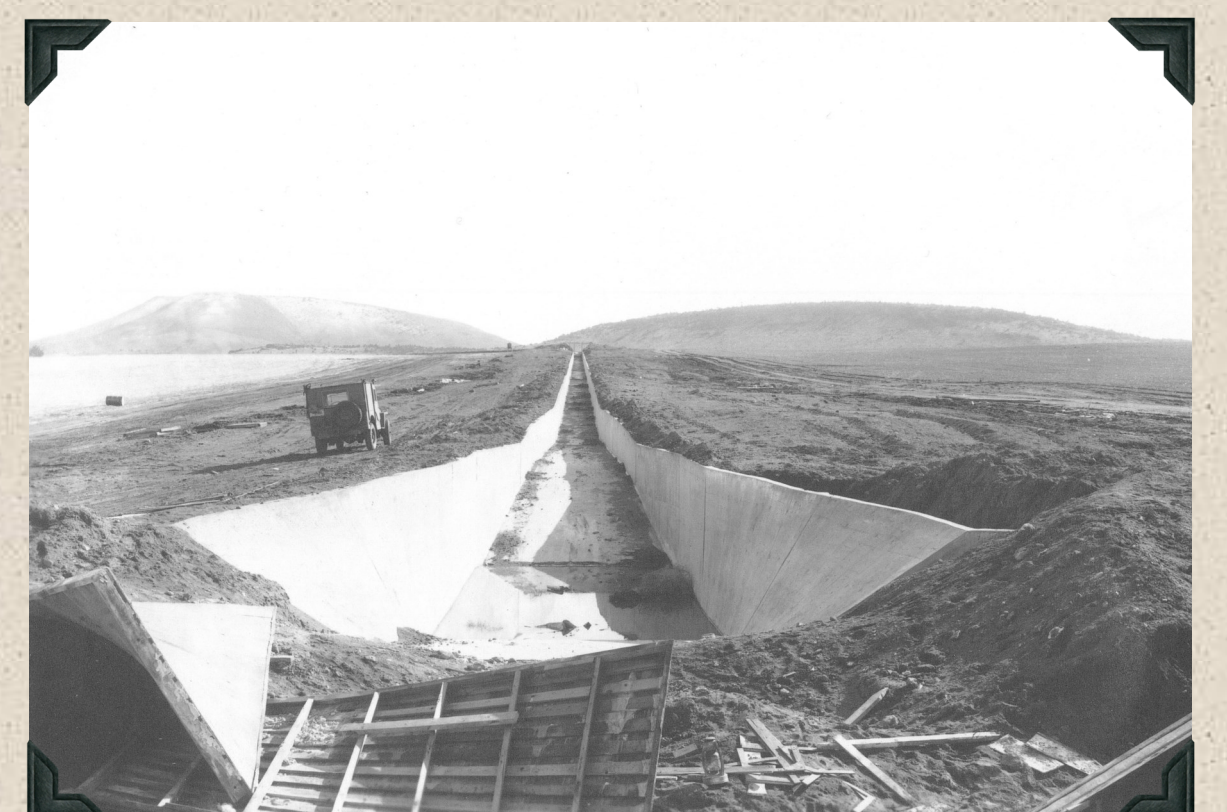
1946 - Looking upstream from foot plank on drop, Lateral M-43, showing concrete chute.

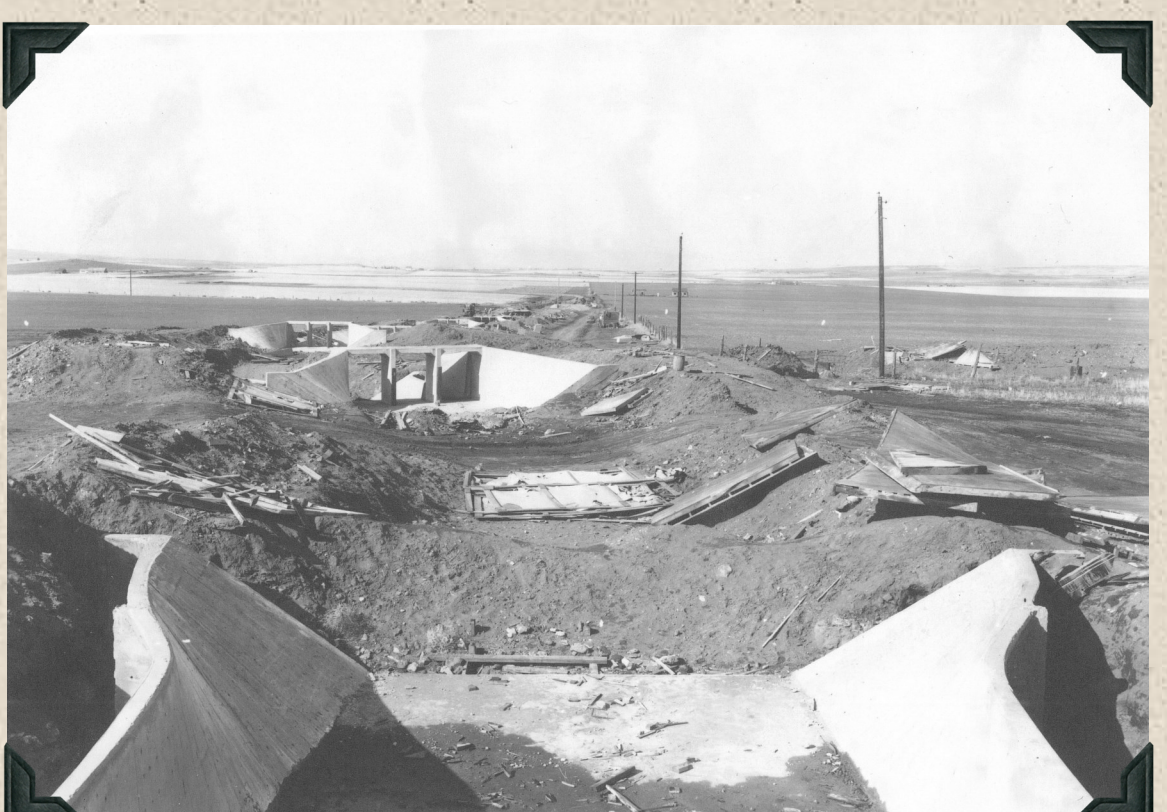
1946 - Looking downstream from foot plank of drop, Lateral M-43. Seven drops in view.

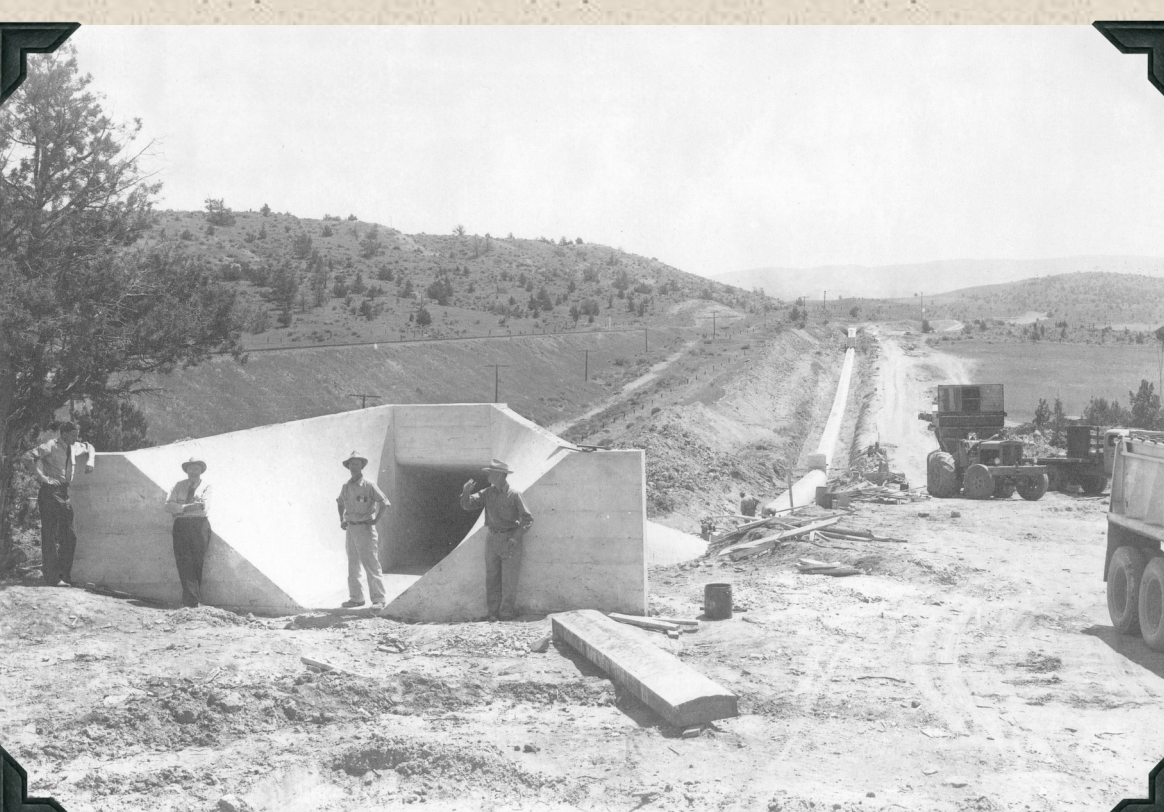
1948 - Lateral M-58. Inlet end of 54" concrete siphon, north of Madras, OR between Highway 26 and Highway 97.

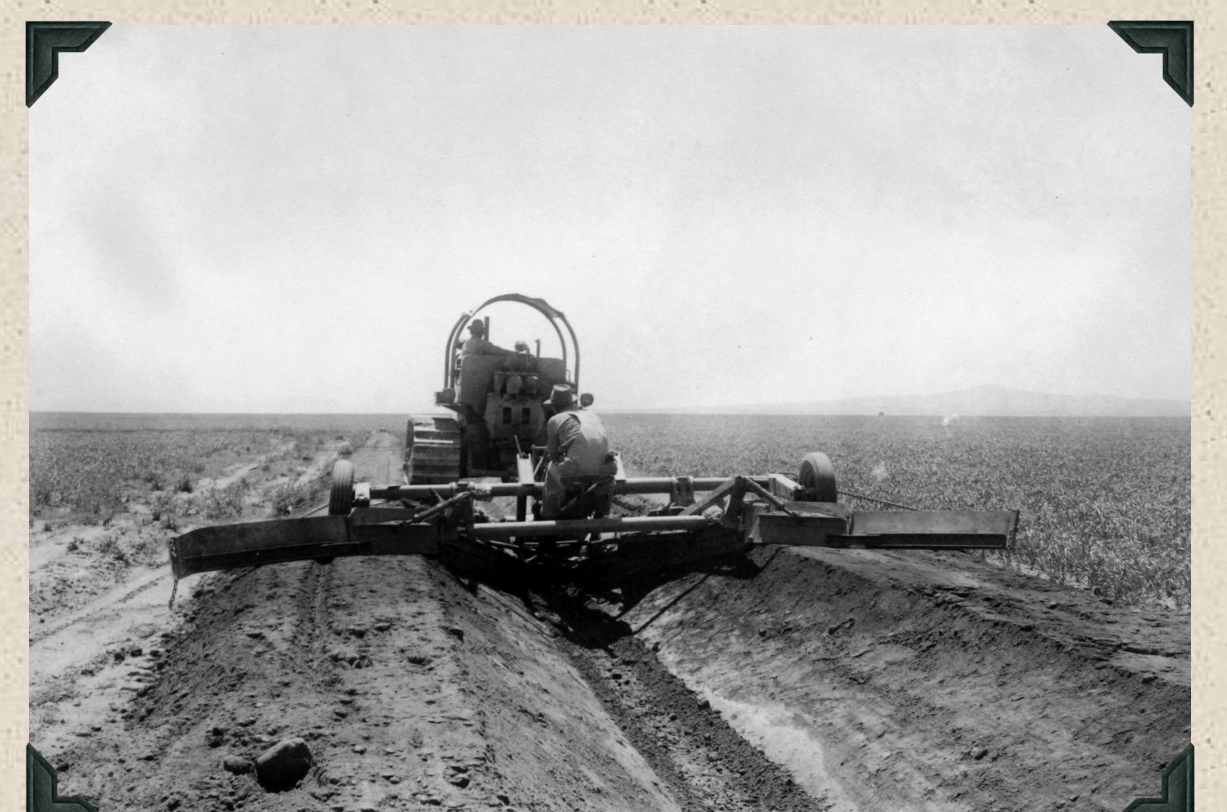
1948 - Rear view of Chattin Ditcher, Model 20-60, used by contractor, W.C. Bauman Co. on Agency Plains lateral system.
